# REMANUFACTURED PARTS

# PRODUCT LINES | EUROPE

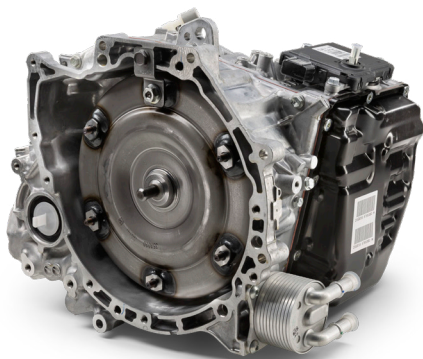
## AUTOMATIC TRANSMISSION

An automatic gearbox enables a vehicle to reach the desired speed, by using its hydraulic coupler which engages the gear.

- Full dismantling of components
- Component checks (dimensions and functions)
- Clean and recondition all parts to their original condition
- Replace damaged or worn parts with new components

- There is an oil leak
- The gearbox makes a noise in neutral
- It is difficult to engage the gears
- There is a dull noise or grinding noise during operation

- Driveshafts
- Oil cooler

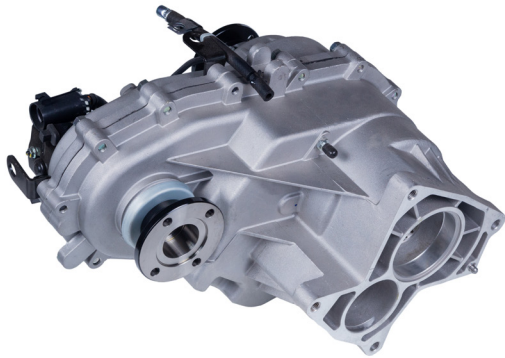
## TRANSMISSION TRANSFER CASE

- Full dismantling of components
- Component checks (dimensions and functions)
- Clean and recondition all parts to their original condition
- Replace damaged or worn parts with new components

- There is an oil leak
- There is damage to the case
- Repair of internal worn or damaged
- There are noises due to speed variation

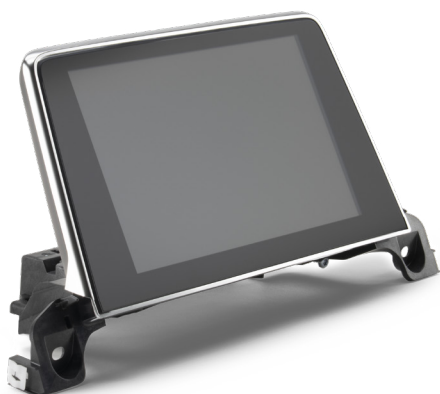
## DISPLAY

- Review the list of faults to identify failures
- Preventive replacement of all worn components
- Each part is tested to ensure the same performance as the genuine part
- Fitting on the identical to the genuine part

- The display must be replaced when:
- Nothing appears on the screen or has some pixel dysfunction
- Some commands do not work anymore
- Sleep mode does not work

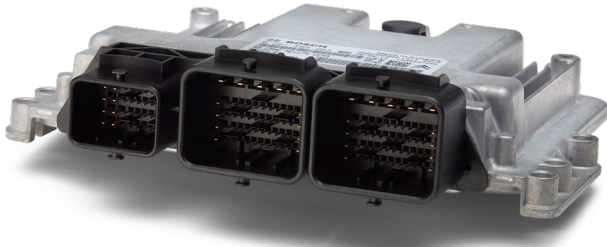
## ENGINE ECU

- Clean the unit and connectors
- Read the list of faults to identify failures
- Preventive replacement of all worn and fragile components to ensure long-term durability
- Full operational test of each BSI/ECU on a simulation bench
- Fitting on the vehicle, identical to the MOPAR genuine part, including the calibration download process

The engine ECU must be replaced when:

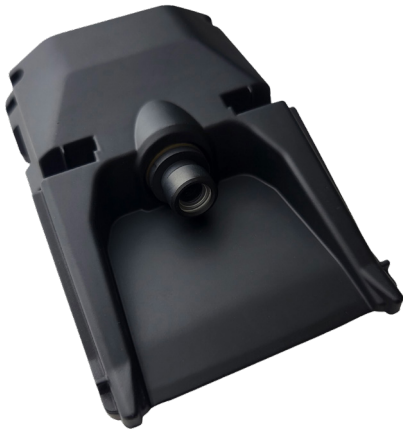
## VIDEO CAMERA

- Cleaning of the unit
- Reading of the list of faults to identify failures
- Preventive replacement of all worn and fragile components to ensure long-term durability
- Full operational test on a simulation bench
- Fitting on the vehicle, identical to the genuine part, including the calibration download process

- When the windshield is replaced
- When an ADAS is not working properly

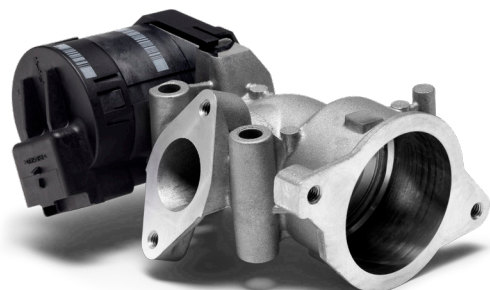
## EGR VALVE

- Full reconditioning of the EGR valve
- Systematic replacement of wear parts: seals, valve, seat, etc.

The exhaust gas recirculation valve must be replaced when:

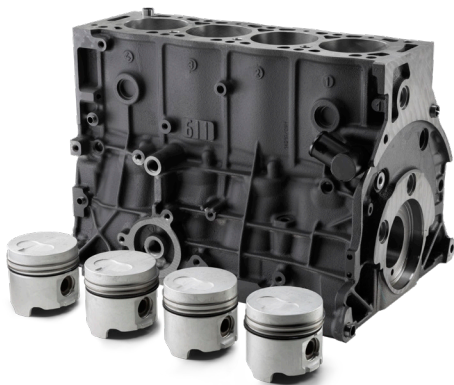
## ENGINE CYLINDER BLOCK

- Systematic replacement of moving parts: piston assemblies, rings, etc., guaranteeing a compression ratio and oil and fuel consumption that is identical to a MOPAR genuine parts engine
- Check noise level (must be identical to a MOPAR genuine part)
- Ensure conformity with electronics, the injection and the exhaust system

- The engine makes a knocking noise when accelerating
- The engine consumes oil
- The timing belt is broken
- There is a loss of power and less compression

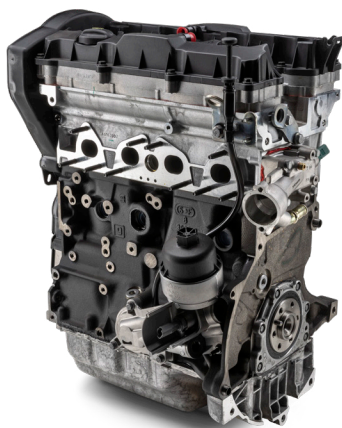
## PETROL & DIESEL ENGINE

- Systematic replacement of moving parts: piston assemblies, valves, etc. to maintain performance, consumption, reliability and durability, identical to the MOPAR genuine part
- Check conformity with electronics, injection, and exhaust system

- It makes a knocking noise when accelerating
- It consumes oil
- A loss of power and compression is noticed
- The timing belt is broken

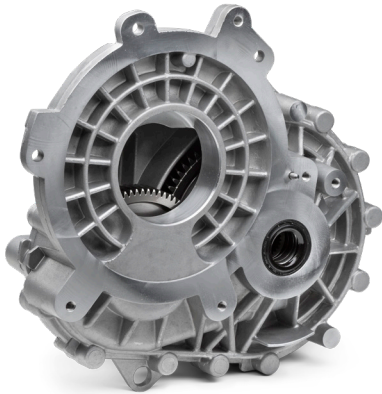
## ELECTRIC REDUCTION GEAR

- Full dismantling of components
- Component checks (dimensions and functions)
- Clean and recondition all parts to their original condition
- Replace damaged or worn parts with new components

The reduction gear must be replaced when:

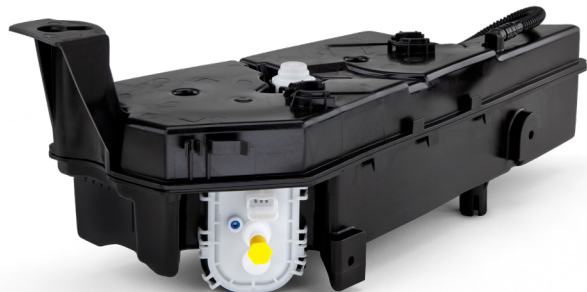
## DPF TANK

Pump and electronic board are disassembled from tank assembly. Each of these 3 components are cleaned, assessed and reassembled if OK or replaced by new ones if needed. Finally, the whole remanufactured tank is tested.

- It is leaking
- Failure code diagnosis points it out.

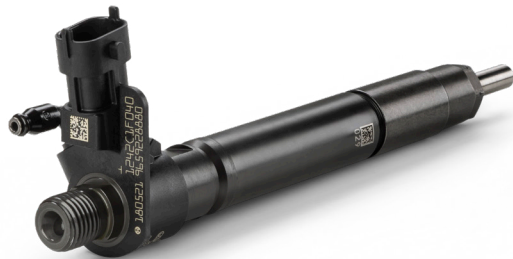
## FUEL INJECTOR & INJECTOR HOLDER

- Full cleaning
- Systematic replacement of wear parts: needle, inlet butterfly valve, solenoid valve
- Check dimensional tolerance and measurement of all components
- Leak and performance test

The injector holder must be replaced when the vehicle has difficulty starting:

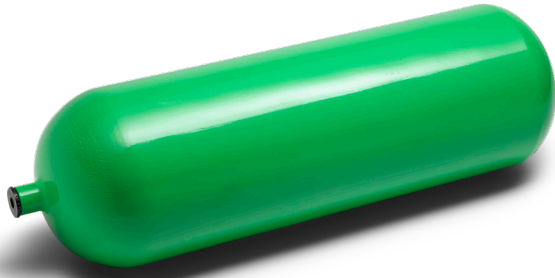
## FUEL TANK

- Clean, check, and repair the sealing

- In the event of a leak
- If there is a problem with filling

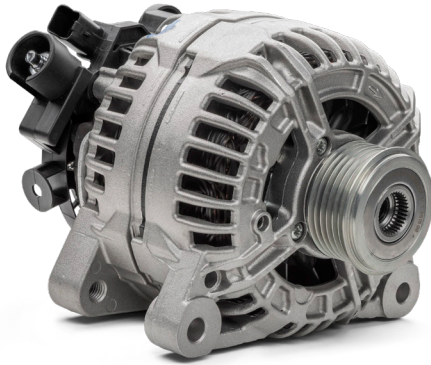
## ALTERNATOR

- Full cleaning
- Systematic replacement of moving parts: bearings, contact brushes, etc.
- Recondition the pulley with the free wheel component
- Durability and output power test for the starter alternator

- The alternator must be replaced when:
- The "battery" warning lamp brightness is low
- The light power of the headlamps decreases

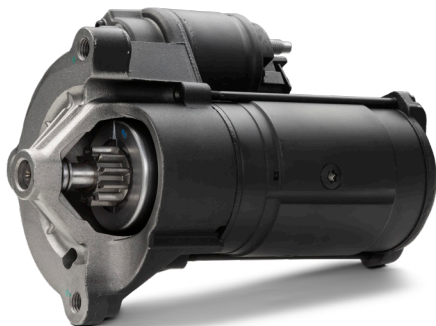
## STARTER

- Full cleaning
- Systematic replacement of moving parts: drive sprockets, bearings, seals, rings, etc.
- Durability and output power test, for Stop and Start starters (STT)

The starter must be replaced when:

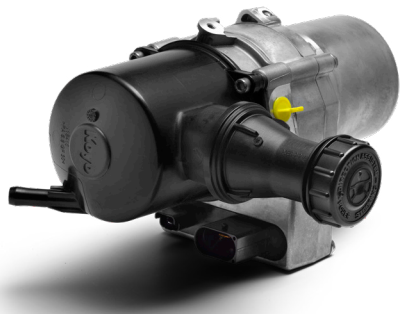
## POWER STEERING PUMP

- Full dismantling of components
- Component checks (dimensions and functions)
- Clean and recondition all parts to their original condition
- Replace damaged or worn parts with new components
- Test the part

The electropump assembly must be replaced when:

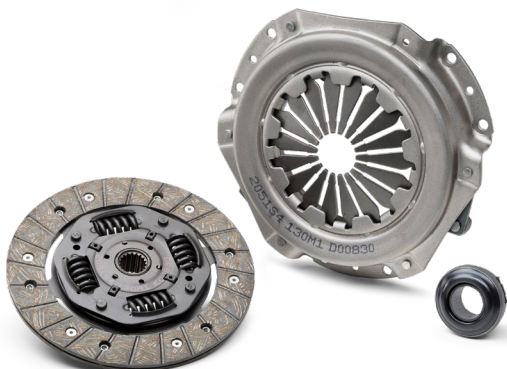
## CLUTCH KIT

- Full cleaning and paintwork for perfect protection against rust
- Systematic replacement of moving parts: friction disc, bearings, etc.
- Check dimensional tolerance and measurement of all components

The clutch kit must be replaced when:

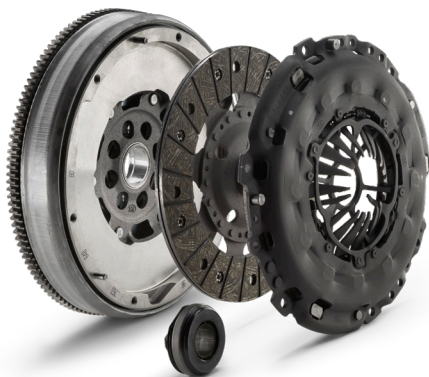
## CLUTCH KIT + DUAL MASS FLYWHEEL

- Resurface the engine flywheel contact area
- Change the clutch friction system
- Change the clutch bearing
- Full dismantling of components
- Component checks (dimensions and functions)
- Clean and recondition all parts to their original condition
- Replace damaged or worn parts with new components

Must be replaced when:

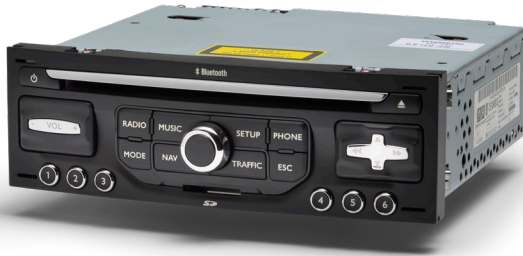
## AUTORADIO

- Clean the unit and connectors
- Read the list of faults to identify failures
- Preventive replacement of all worn and fragile components
- Full operational test on a test bench
- Fitting on the vehicle, identical to the genuine part including the calibration download process if required

The autoradio system must be replaced when:

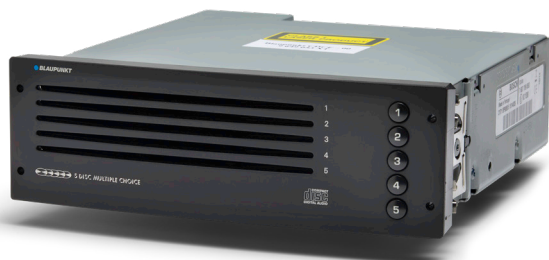
## CD CHANGER

- Clean the unit and connectors
- Read the list of faults to identify failures
- Preventive replacement of all worn and fragile components to ensure long-term durability
- Full operational test on a simulation bench
- Fitting on the vehicle, identical to the genuine part

The CD changer must be replaced when:

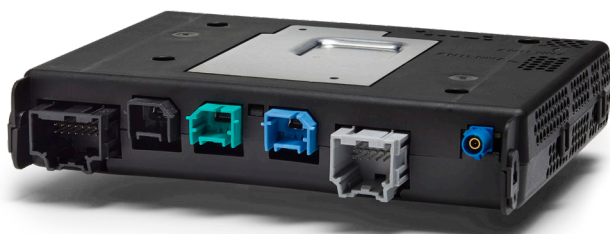
## NAVIGATION SYSTEM

- Dismantle and replace faulty components

- The navigation system must be replaced when:
- The GPS function no longer works

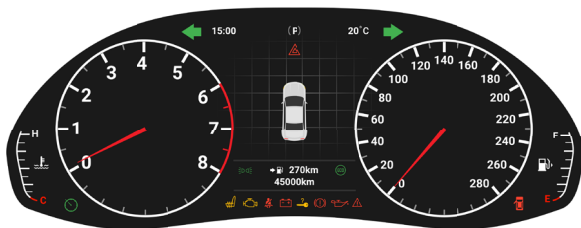
## CLUSTER

- Clean the unit and connectors
- Read the list of faults to identify failures
- Preventive replacement of all worn and fragile components to ensure long-term durability
- Full operational test of the dashboard

- You start the engine and bulbs don't work as they should
- One or several instrumentations do not work (speedometer, tachometer...)
- Determined as defective after diagnostics by a certified technician

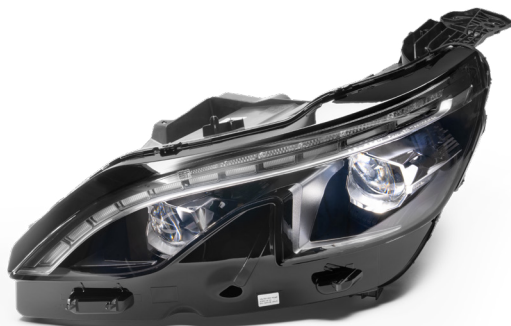
## HEADLAMP

- The part is dismantled, the glass and the housing are changed, the electronic & LED modules are tested and repaired.

- The headlamp must be replaced when: it no longer works or the glass is broken.
